HARRISBURG AREA
GEOLOGICAL SOCIETY
FIELD TRIP GUIDEBOOK
ANTHRACITE REGION

JUNE 2002

INTRODUCTION

This field trip will travel to the Southern Anthracite region of Pennsylvania to examine the stratigraphy, structure, and environmental aspects of coal mining. During this trip, we will visit:

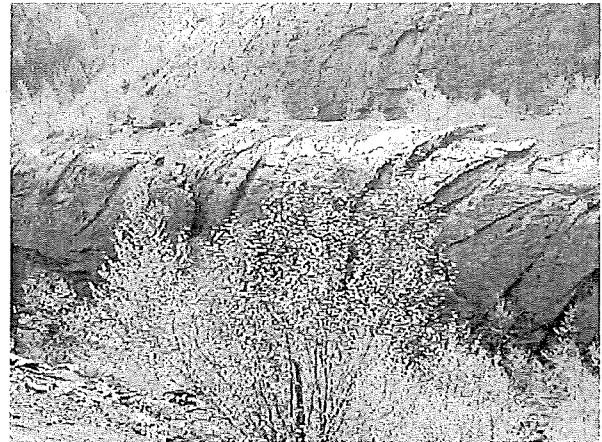
“Whaleback” anticline at Bear Valley

Structural Geology: The most dramatic structural feature is the “Whaleback anticline” in the center of the mine. Walking along the crest of the anticline you will observe the best exposure of the disharmonic folding, which is visible in the east highwall of the mine. Thrust faults can be observed at the extreme southwest corner of the mine (Location C on the geologic map below) as well as elsewhere in the mine (locations B, D, and F). Extensional grabens and wrench faults are visible along the north limb of the Whaleback anticline (locations F and G).

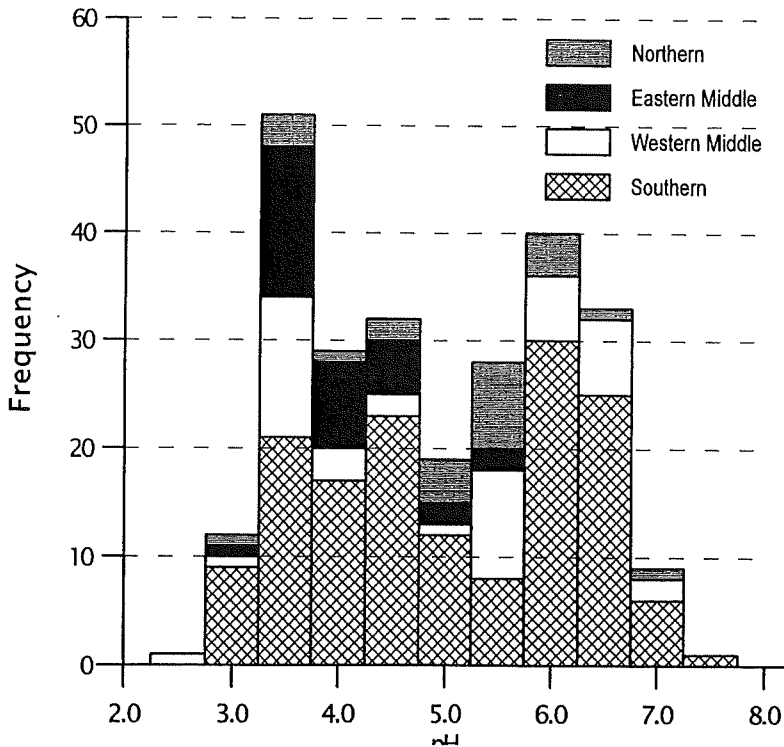
The figure below shows the distribution of pH for mine drainage in the Anthracite Region in 1977. The distribution is bimodal, with discharges being either acidic (pH ~3.5) or near-neutral (pH ~6.0). The headwaters of Swatara Creek are located in the Southern Field.

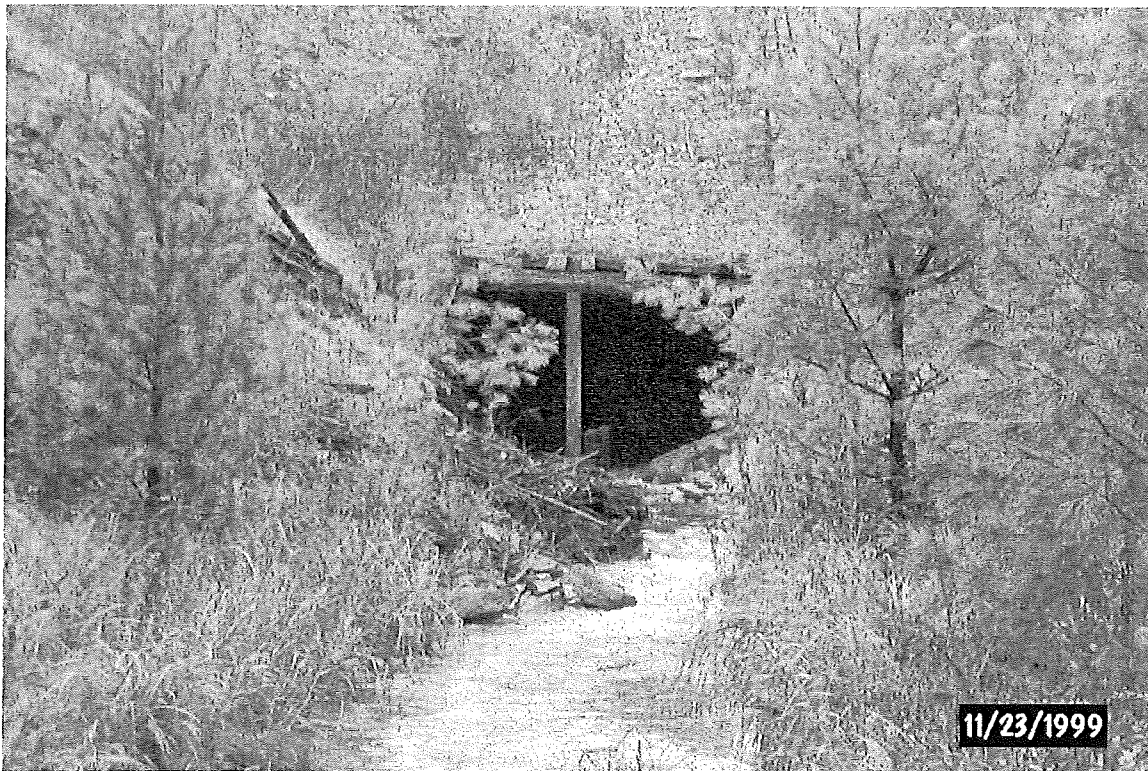
Rowe Tunnel Discharge.

Median water quality from the Rowe tunnel for 79 samples collected between January 1990 and February 1998 was pH 5.8; conductivity 238 μ S/cm; acidity 18 mg/L; alkalinity 9 mg/L; Al 0.9 mg/L; Fe 8.6 mg/L; Mn 1.9 mg/L and sulfate 106 mg/L. Flow ranges from 340 to 1300 gpm, with a median of 1,770 gpm.
